Policy and Improper Management of the Dams realized by Local Materials with Possible Risk in Exploitation

Victorita RADULESCU*

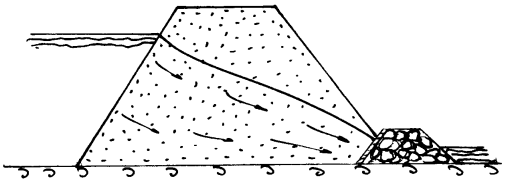
Figure 2. The model of infiltration through dams

Schematically, the problem of infiltration through dams is presented in Figure 2. One of the most important parameters in seepage analysis is the porosity of the material found in the dam structure and lack of the sealing systems and the presence or absence of protection screens.

The theoretical estimation is different from the real one, measured in-situ. If from the entire area of the filter we consider the real pores, the velocity V' becomes greater than the theoretical one-ω due to the huge variation of the structure of the dams material and partially of the presence of some small protection screens. This is the first reason why even from the moment of designing and the execution of the dams, the local authorities confront with infiltration impossible to drain.

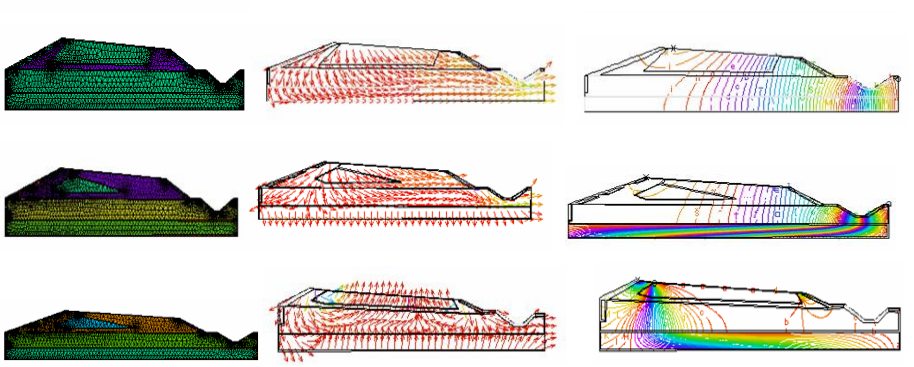
Figure 3. Numerical results, Variant A, B, C, D

Furthermore, are presented some numerical results, Figure 3 with different dam structures, different finite element mesh, velocity distribution, the streamlines variation:

Variant A-area with the continuous screen until the bedrock,

Variants B, C, D – with sections with different values of the water level infiltration, depending on the local porosity of the dikes material in the cross-sections and the position of the base bedrock, where there is no infiltrations.
